# LV 7-3 Ø FSA

# 3. Tørkegruppe PM 4

# Lagerhus, strekk og reguleringsvalser:

Filtledervals (reguleringsvals) PM II  
14.01.97 BES

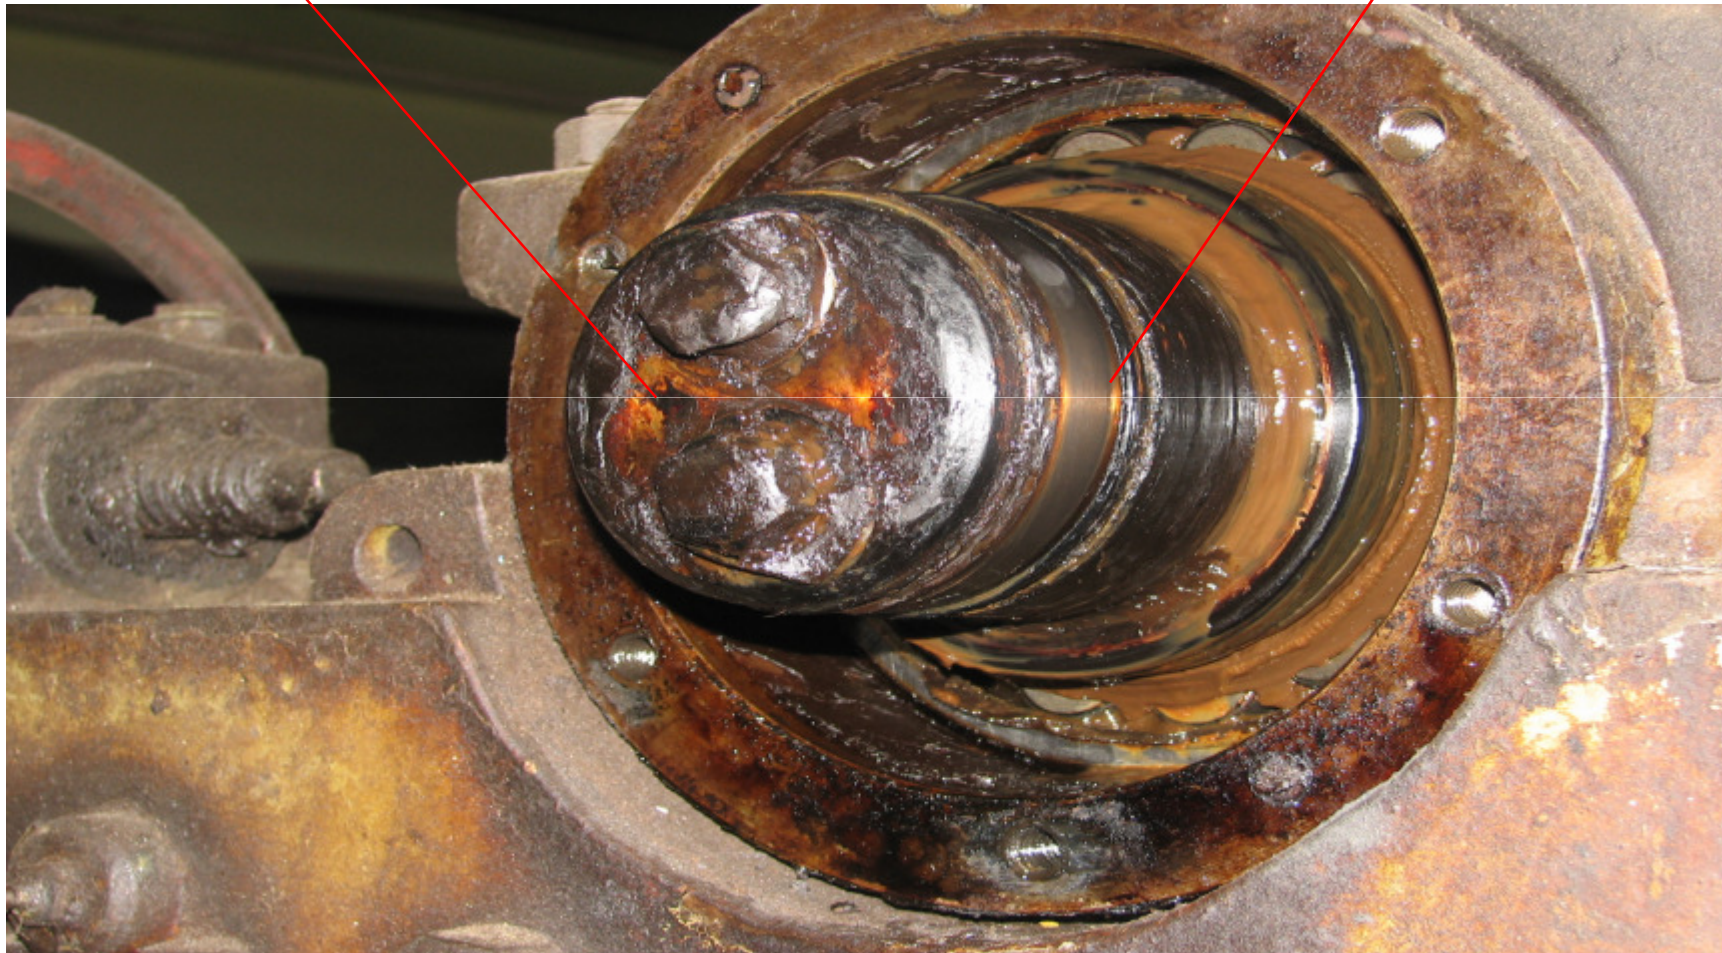
Her er det startet rengjøring, som man kan se er det ikke skjedd stor skade på tappen, noe slitt er den nok, da vi har hatt en innerring som har vært løs. Gjengene til boltene er ok, og man kan montere lageret på plass igjen.

Limer med loctite, for at det skal sitte ennå bedre. Valsen er sikret, for så å bli byttet i en planlagt stopp.

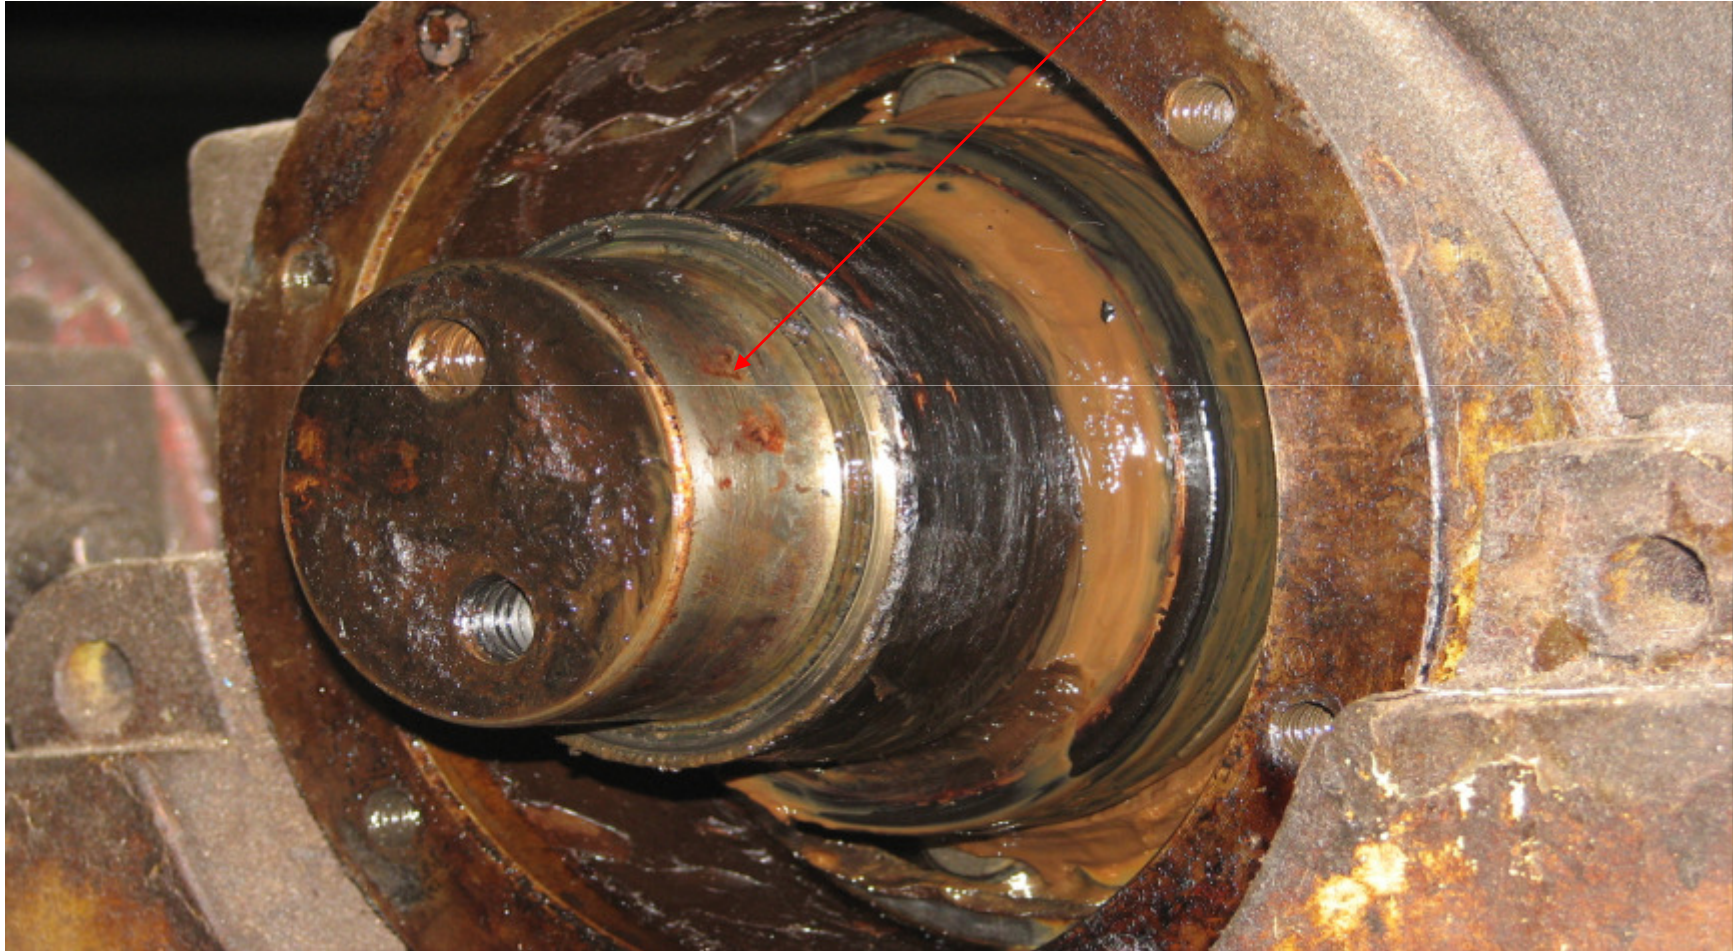
En måling tatt dagen etter, for å kontrollere at ting er som det bør.  
Valsen vil bli lagt under oppfølging slik at den hele tiden blir observert.
